PHOTOGRAPHIC SURVEY OF THE LDEF MISSION

National Aeronautics and
Space Administration

NASA Special Publication 531
1996

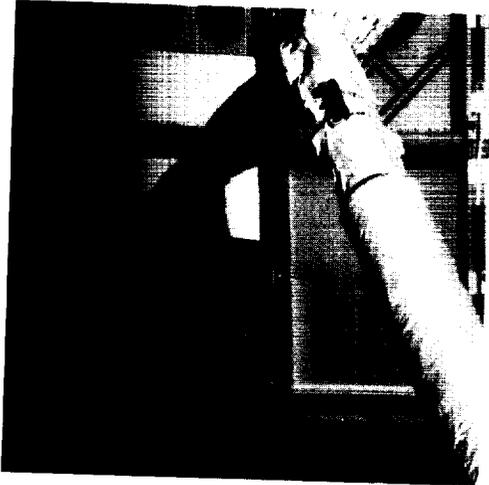
Figure 147 (In Flight). The pink and greenish-gray tints on the two debris panels are by-products of the chromic anodization coating process and are not attributed to contamination or exposure to the space environment.

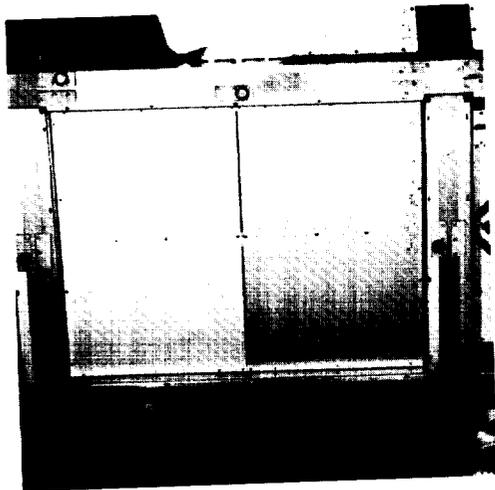
Figure 148
Photo No.: KSC-390C-1066.11
Dup. Neg. No.: L90-13480
LISAR No.: EL-1994-00189
Photo Credit: KSC
Photo Date: 2/8/90
Location: KSC SAEF II
Subject: Postflight Survey of Tray B1

Figure 148 (Postflight). The pink and greenish-gray tints on the two debris panels are by-products of the chromic anodization coating process and are not attributed to contamination or exposure to the space environment. The light bands along the bottom and the left and right edges of the panels are caused by lights reflecting from the tray sidewalls. The two small mounds on the panel on the left are manufacturing defects that existed prior to flight. Markings along the top of the photograph are the result of film processing.

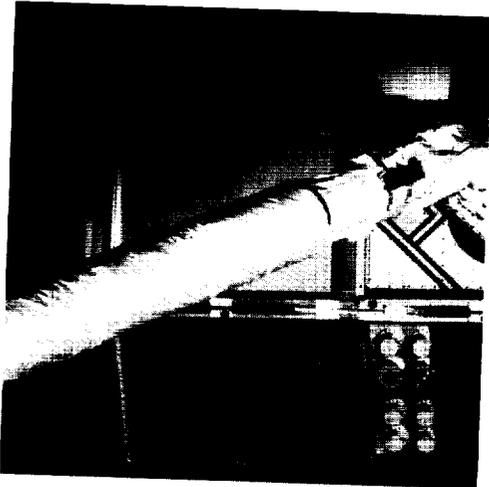
Figure 149
Photo No.: S32-78-016
Dup. Neg.: L90-10427
LISAR No.: EL-1994-00004
Photo Credit: JSC
Photo Date: 1/12/90
Location: In Flight
Subject: In-Flight Survey of Tray B2

Figure 149 (In Flight). The greenish-gray tint on the left debris panels and the pink tint on the right debris panel are by-products of the chromic anodization coating process. The light band along the left side and across the bottom of the panels is caused by light reflecting from the tray sidewalls.

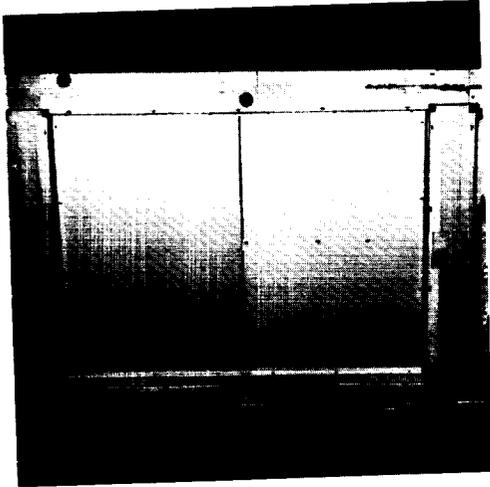
Figure 150
Photo No.: KSC-390C-1066.05
Dup. Neg. No.: L90-13474
LISAR No.: EL-1994-00386
Photo Credit: KSC
Photo Date: 2/8/90
Location: KSC SAEF II
Subject: Postflight Survey of Tray B2

Figure 150 (Postflight). The pink and greenish-gray tints on the two debris panels are by-products of the chromic anodization coating process and are not attributed to contamination or exposure to the space environment. The light band along the sides and across the bottom of the panels is caused by light reflecting from the tray sidewalls.

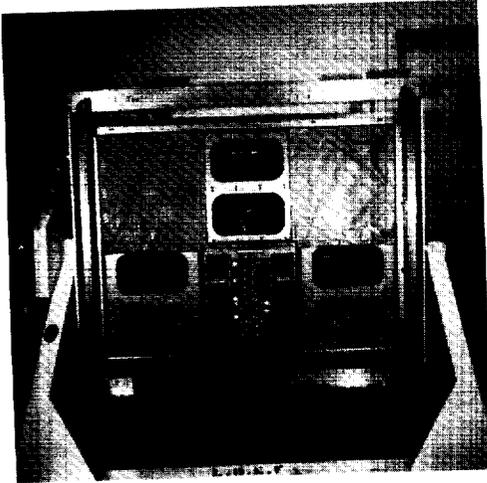
Figure 153
Photo No.: KSC-390C-1646.09
Dup. Neg. No.: L91-7874
LISAR No.: EL-1994-00217
Photo Credit: KSC
Photo Date: 3/6/90
Location: KSC SAEF II
Subject: Postflight Survey of Tray B3

Figure 153 (Postflight). The experiment appears to have no physical damage except for a tear in thermal cover and some discolored areas. The material samples on the bottom corners of the two lower canister cover plates do not appear to be discolored.

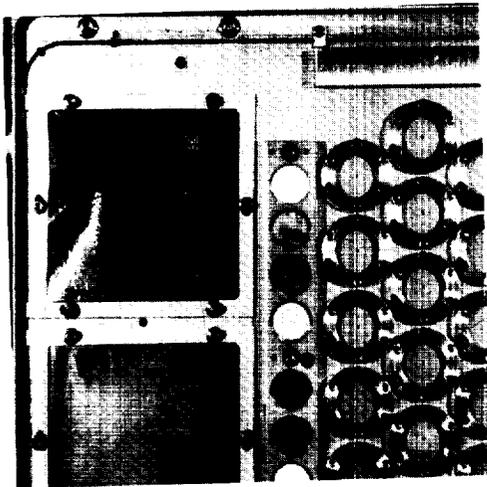
Figure 154
Photo No.: KSC-390C-1648.08
Dup. Neg. No.: L91-7895
LISAR No.: EL-1994-00368
Photo Credit: KSC
Photo Date: 3/6/90
Location: KSC SAEF II
Subject: Postflight Detail of Upper Left of Lower
Center of Tray B3

Figure 154 (Postflight). This close-up of the upper left of the lower center of the tray shows that the experiment mounting plate has a darker color than before flight. The test samples appear wrinkled but are intact.

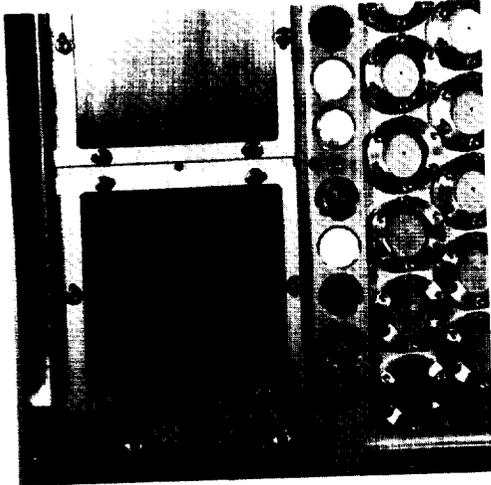
Figure 157
Photo No.: KSC-390C-1649.01
Dup. Neg. No.: L91-7899
LISAR No.: EL-1994-00218
Photo Credit: KSC
Photo Date: 3/6/90
Location: KSC SAEF II
Subject: Postflight Detail of Lower Left of Lower
Center of Tray B3

Figure 157 (Postflight). This close-up of the lower left of the lower center tray shows that the experiment mounting plate is a darker color than before flight. The test samples appear wrinkled but are intact.

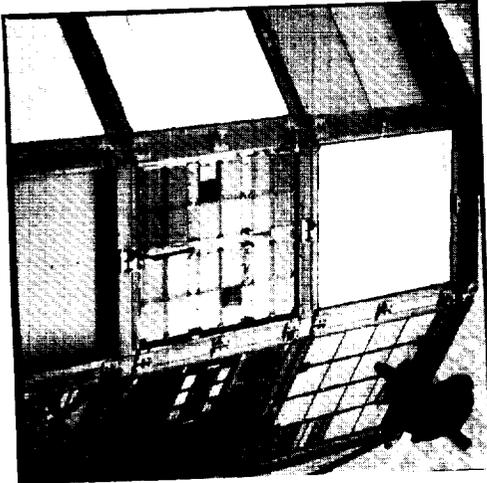
Figure 159
Photo No.: S32-77-027
Dup. Neg.: L90-10407
LISAR No.: EL-1994-00090
Photo Credit: JSC
Photo Date: 1/12/90
Location: In Flight
Subject: In-Flight Survey of Tray B4

Figure 159 (In Flight). The experiment appears to have no physical damage from exposure to the space environment. The lighting is such that changes in material colors are difficult to detect; however, the white paint in the vicinity of the solar cell modules appears to have darkened.

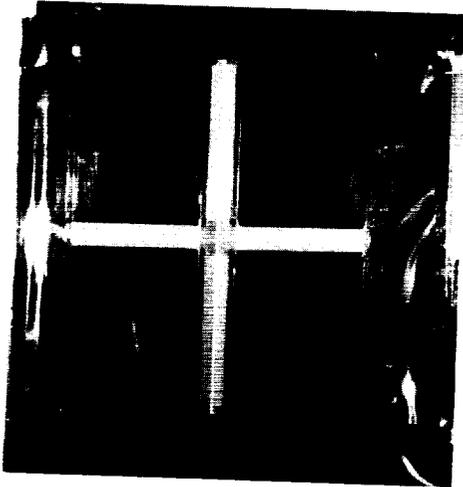
Figure 161
Photo No.: KSC-390C-2117.02
Dup Neg. No.: L91-7930
LISAR No.: EL-1994-00497
Photo Credit: KSC
Photo Date: 3/20/90
Location: KSC SAEF II
Subject: Postflight Detail of Upper Left of Tray B4

Figure 161 (Postflight). This photograph of the upper left one-sixth of the tray shows that the experiment has no apparent physical damage. Surfaces remain highly reflective.

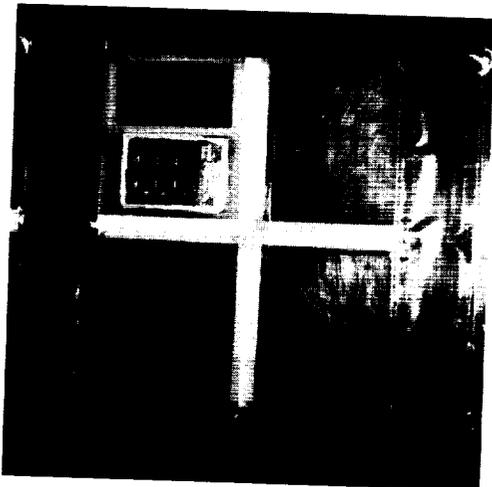
Figure 162
Photo No.: KSC-390C-2117.03
Dup. Neg. No.: L91-7931
LISAR No.: EL-1994-00498
Photo Credit: KSC
Photo Date: 3/20/90
Location: KSC SAEF II
Subject: Postflight Detail of Upper Center of
Tray B4

Figure 162 (Postflight). This photograph of the upper center one-sixth of the tray shows that the experiment has no apparent physical damage. Surfaces remain highly reflective. The white paint around the outer edges of the solar cell modules appears to have changed to a light tan.

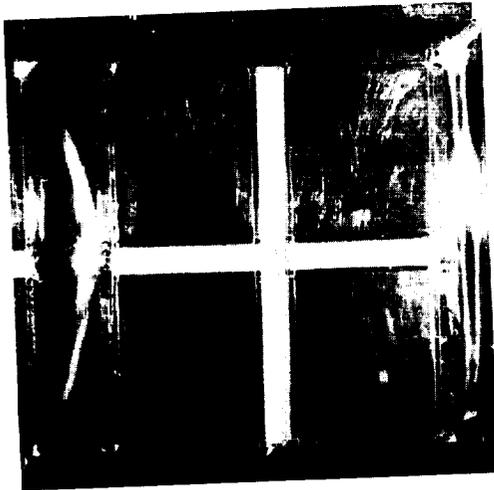
Figure 163
Photo No.: KSC-390C-2117.04
Dup. Neg. No.: L91-7932
LISAR No.: EL-1994-00499
Photo Credit: KSC
Photo Date: 3/20/90
Location: KSC SAEF II
Subject: Postflight Detail of Upper Right of Tray B4

Figure 163 (Postflight). This photograph is of the upper right one-sixth of the tray. It shows the experiment with no apparent physical damage. Surfaces remain highly reflective.

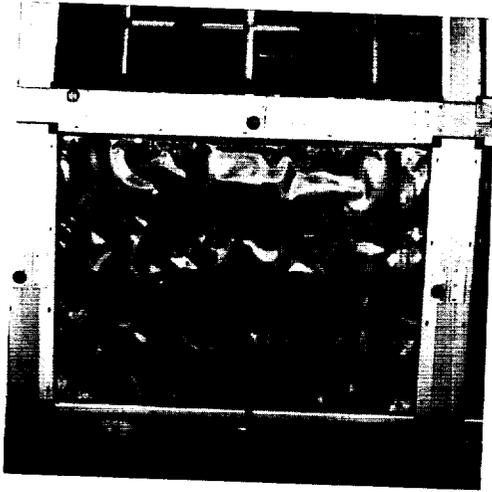
Figure 168
Photo No.: KSC-390C-1035.08
Dup. Neg. No.: L90-13453
LISAR No.: EL-1994-00184
Photo Credit: KSC
Photo Date: 2/9/90
Location: KSC SAEF II
Subject: Postflight Survey of Tray B5

Figure 168 (Postflight). The thermal cover appears to be specular with no apparent damage. The cover is less taut than in the in-flight photograph and the locations of Velcro attachment pads are not as prominent. The scallop effect around the cover edges occurs between the attachment pads and shows the upper edge of the support frame. The ground strap is in place with no visible damage.

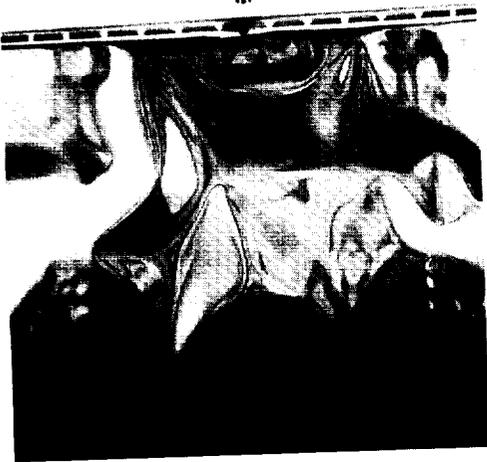
Figure 170
Photo No: KSC-390C-2151.06
Dup. Neg. No.: L91-7975
LISAR No.: EL-1994-00514
Photo Credit: KSC
Photo Date: 3/21/90
Location: KSC SAEF II
Subject: Postflight Detail of Upper Center of
Thermal Cover of Tray B5

Figure 170 (Postflight). This photograph is of the upper center one-sixth of the tray. The thermal cover appears specular with no apparent damage. The reflective properties of the uneven surface of the cover result in various light and color patterns. A few impact or penetration discolorations are visible.

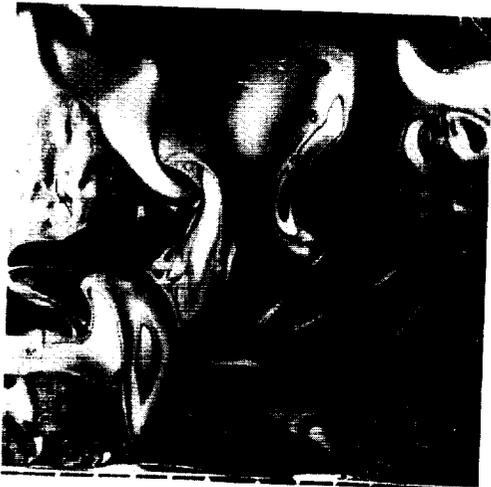
Figure 173
Photo No.: KSC-390C-2151.12
Dup. Neg. No.: L91-7981
LISAR No.: EL-1994-00517
Photo Credit: KSC
Photo Date: 3/21/90
Location: KSC SAEF II
Subject: Postflight Detail of Lower Center of
Thermal Cover of Tray B5

Figure 173 (Postflight). This photograph is of the lower center one-sixth of the tray. The thermal cover appears specular with no apparent damage. The reflective properties of the uneven surface of the cover result in various light and color patterns. A few impact or penetration discolorations are visible.

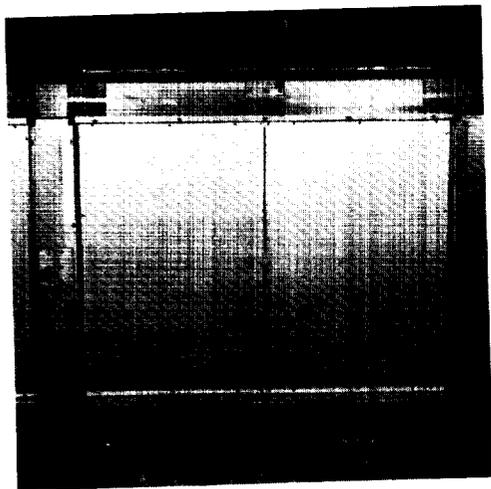
Figure 176 (Postflight). The pink and greenish-gray tints on the two debris panels are by-products of the chromic anodization coating process and are not attributed to contamination or exposure to the space environment. The fingerprints along the inner edges of the debris panels that were observed in the in-flight photograph are still visible. The dark vertical streaks on the debris panels in the in-flight photographs are almost invisible because the reflection of the sky is not present. The light band along the sides and across the bottom of the panels is caused by light reflecting from the tray sidewalls.

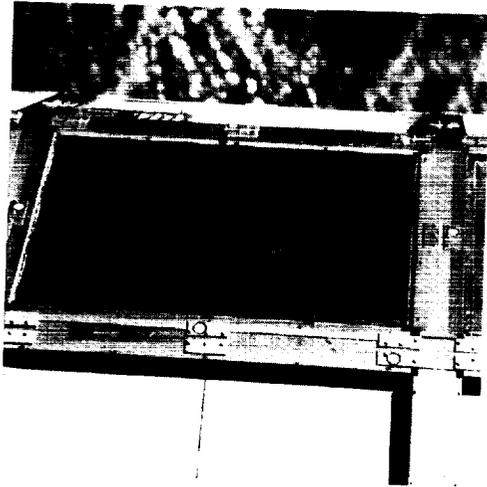
Figure 177 (In Flight). The thermal cover appears to have no apparent damage, but it is more taut than in the prelaunch photograph. The dark blue appearance of the thermal cover in this photograph is caused by lighting conditions and is not due to a change in the optical properties of the material. The oblong indentations on the thermal cover are areas where Velcro pads are bonded to the back of the cover. The surface of the thermal cover appears to have small brown circular discolorations of various sizes that appear to result from impacts or penetrations. A large light blue area of discoloration is clearly visible in the lower right quadrant of the thermal cover. The discoloration is probably the result of an impact penetrating the 5-mil Teflon film and upsetting the layer of vapor-deposited silver beneath. The scalloped edge along the left side of the thermal cover occurs between attachment pads. The ground strap appears to be in place with no visible damage, but it appears to be a deeper copper color than in the prelaunch photograph.

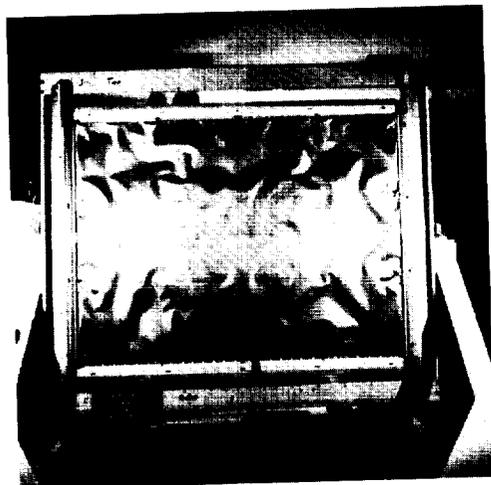
Figure 178
Photo No.: KSC-390C-2306.09
Dup. Neg. No.: L91-8035
LISAR No.: EL-1994-00312
Photo Credit: KSC
Photo Date: 3/26/90
Location: KSC SAEF II
Subject: Postflight Survey of Tray B7

Figure 178 (Postflight). The surface of the thermal cover appears to have changed from specular to opaque with black dots of various sizes that appear to be impacts or penetrations. A large area of white discoloration is clearly visible in the upper left quadrant of the thermal cover. The discoloration is probably the result of a penetration of the 5-mil Teflon film that has affected the layer of vapor-deposited silver beneath. The cover is not as taut as in the in-flight photograph and the locations of Velcro attachment pads are not as prominent. The ground strap is in place with no visible damage, but it is a deeper copper color than in the prelaunch photograph.

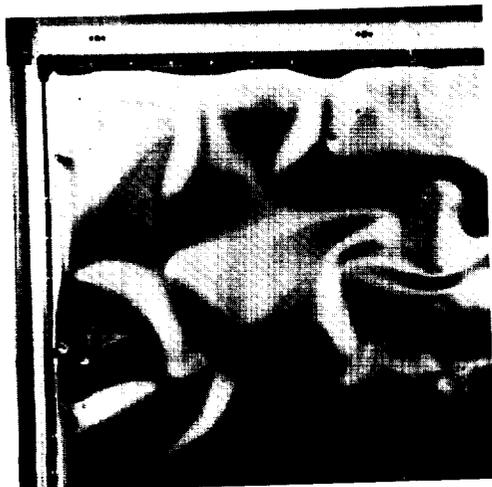
Figure 179
Photo No.: KSC-390C-2306.10
Dup. Neg. No.: L91-8036
LISAR No.: EL-1994-00573
Photo Credit: KSC
Photo Date: 3/26/90
Location: KSC SAEF II
Subject: Postflight Detail of Upper Left of Thermal Cover of Tray B7

Figure 179 (Postflight). This close-up photograph is of the upper left one-sixth of the tray. The thermal cover appears to be opaque rather than specular as it was in preflight photographs. Numerous impact or penetration discolorations are visible. The thermal cover Velcro tie-down pads are also evident.

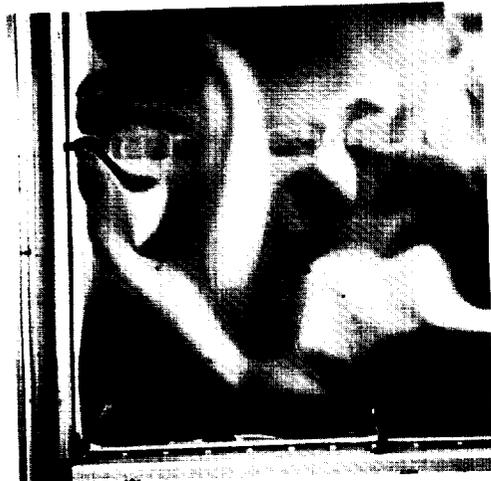
Figure 182
Photo No.: KSC-390C-2307.05
Dup. Neg. No.: L91-8019
LISAR No.: EL-1994-00576
Photo Credit: KSC
Photo Date: 3/26/90
Location: KSC SAEF II
Subject: Postflight Detail of Lower Left of Thermal
Cover of Tray B7

Figure 182 (Postflight). This close-up photograph is of the lower left one-sixth of the tray. The thermal cover appears to be opaque rather than specular as it was in preflight photographs. Numerous impact or penetration discolorations are visible. The thermal cover Velcro tie-down pads are also evident.

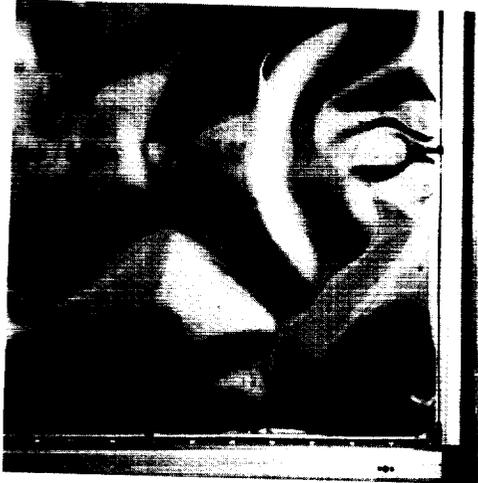
Figure 184
Photo No.: KSC-390C-2307.07
Dup. Neg. No.: L91-8021
LISAR No.: EL-1994-00595
Photo Credit: KSC
Photo Date: 3/26/90
Location: KSC SAEF II
Subject: Postflight Detail of Lower Right of Tray B7

Figure 184 (Postflight). This close-up photograph is of the lower right one-sixth of the tray. The thermal cover appears to be opaque rather than specular as it was in preflight photographs. Numerous impact or penetration discolorations are visible. The thermal cover Velcro tie-down pads are also evident.

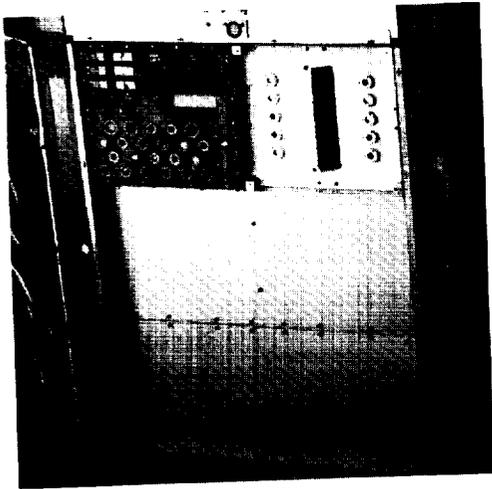
Figure 186
Photo No.: S32-76-026
Dup. Neg. No.: L90-10380
LISAR No.: EL-1994-00665
Photo Credit: JSC
Photo Date: 1/12/90
Location: In Flight
Subject: In-Flight Survey of Tray B8

Figure 186 (In Flight). Here, the space debris impact panels have a very distinct green and pink color that varies as the light angle changes across the panels. The different colors of the infrared filter surfaces of experiment AO056 may be reflections of the surrounding environment and are not from exposure to space. A brown discoloration is present on the unpainted aluminum mounting plate. Experiment AO147 appears to have no physical damage. The white paint on the aluminum mounting plate has several irregular-shaped black marks along the top edge. The marks were not visible on the prelaunch photograph.

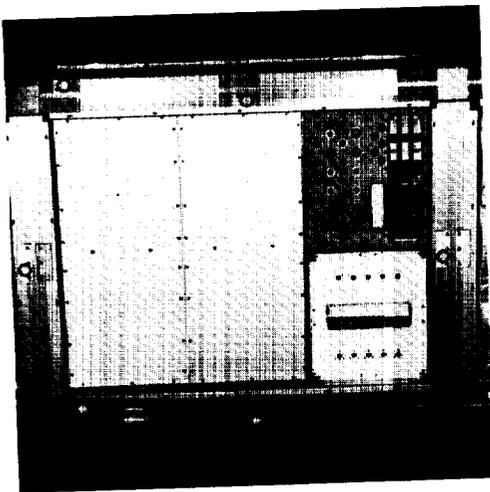
Figure 187
Photo No.: KSC-390C-1031.11
Dup. Neg. No.: L90-13421
LISAR No.: EL-1994-00146
Photo Credit: KSC
Photo Date: 2/9/90
Location: KSC SAEF II
Subject: Postflight Survey of Tray B8

Figure 187 (Postflight). Experiment AO056 appears unchanged from the in-flight photograph. The apparent blue, green, silver, and white colors of coatings and filter samples observed in the in-flight photographs are not visible. A brown discoloration is present on the surface of the unpainted aluminum mounting plate. The discoloration is darker near the fasteners around the mounting plate edges and the filter and coating holders. Experiment AO147, which is located in the lower right of the tray, appears to be without physical damage. Experiment S0001 shows the familiar green and pink that is caused by anodization.

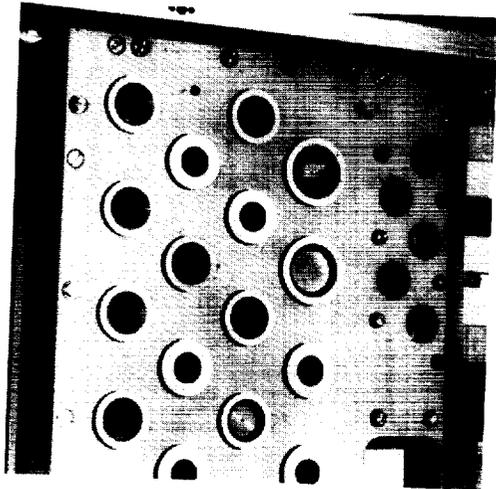
Figure 188
Photo No.: KSC-390C-1931.09
Dup. Neg. No.: L91-8064
LISAR No.: EL-1994-00431
Photo Credit: KSC
Photo Date: 3/14/90
Location: KSC SAEF II
Subject: Postflight Detail of Upper Right of Tray B8

Figure 188 (Postflight). This photograph is of the upper left one-fourth of the module for experiment AO056. The experiment is intact, but has sustained some physical damage. The experiment sample located in the second circular holder from the top in the right row appears to be missing. A brown discoloration is present on the surface of the unpainted aluminum mounting plate. The discoloration is darker near the fasteners around the mounting plate edges and the filter and coating holders.

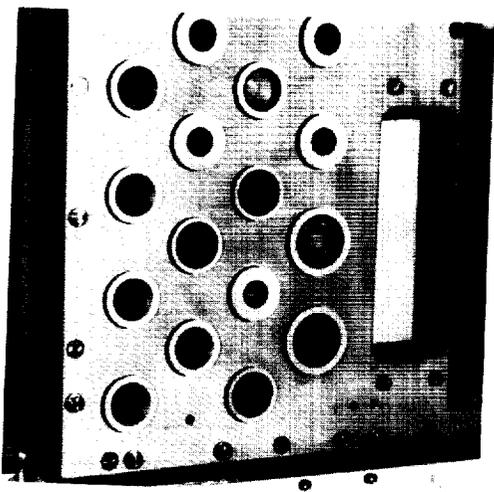
Figure 189
Photo No.: KSC-390C-1931.10
Dup. Neg.: L91-8065
LISAR No.: EL-1994-00432
Photo Credit: KSC
Photo Date: 3/14/90
Location: KSC SAEF II
Subject: Postflight Detail of Upper Right of Tray B8

Figure 189 (Postflight). This photograph is of the lower left one-fourth of the module for experiment AO056. The experiment has sustained some physical damage. An impact crater and two cracks extending outward from the crater are visible in the experiment sample mounted in the second circular holder from the bottom in the right row of filter and coating samples. A brown discoloration is present on the surface of the unpainted aluminum mounting plate and near the filter and coating holders.

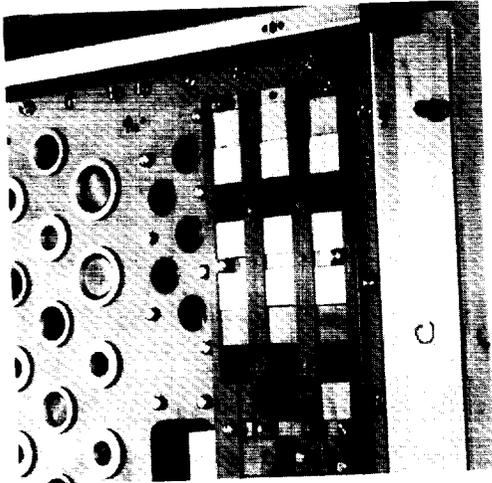
Figure 190
Photo No.: KSC-390C-1931.11
Dup. Neg. No.: L91-8066
LISAR No.: EL-1994-00433
Photo Credit: KSC
Photo Date: 3/14/90
Location: KSC SAEF II
Subject: Postflight Detail of Upper Right of Tray B8

Figure 190 (Postflight). This photograph is of the upper right one-fourth of the module for experiment AO056. The experiment is intact, but brown discolorations appear on surfaces of the Materials Technology Experiment samples that are mounted in the right half of the module.

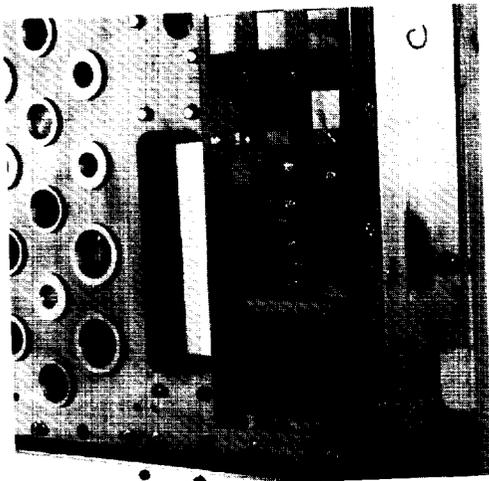
Figure 191
Photo No.: KSC-390C-1931.12
Dup. Neg. No.: L91-8067
LISAR No.: EL-1994-00434
Photo Credit: KSC
Photo Date: 3/14/90
Location: KSC SAEF II
Subject: Postflight Detail of Lower Right of Tray B8

Figure 191 (Postflight). This photograph is of the lower right one-fourth of the module for experiment AO056. The experiment is intact, but brown discolorations appear on surfaces of the Materials Technology Experiment samples that are mounted in the right half of the module.

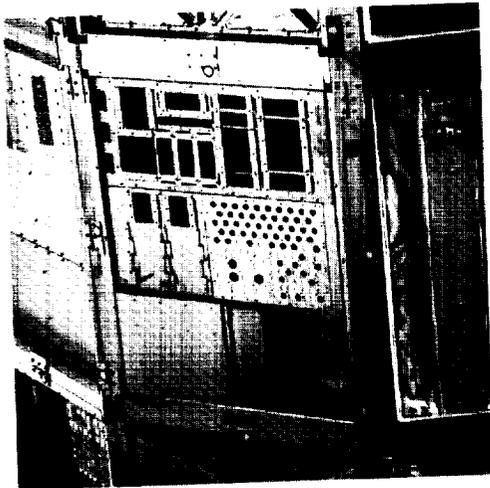
Figure 193
Photo No.: S32-76-001
Dup. Neg. No.: L90-10374
LISAR No.: EL-1994-00659
Photo Credit: JSC
Photo Date: 1/12/90
Location: In Flight
Subject: In-Flight Survey of Tray B9

Figure 193 (In Flight). In this photograph, the top and lower flanges have abrasions from prelaunch testing. Experiment AO147 component, located on the upper one-third of the tray mounting plate, is intact and the mounting hardware appears secure. Much of the mounting hardware is discolored. In the left center, only a few fragments of the 14 polymeric and resin thin-film materials have survived the mission.

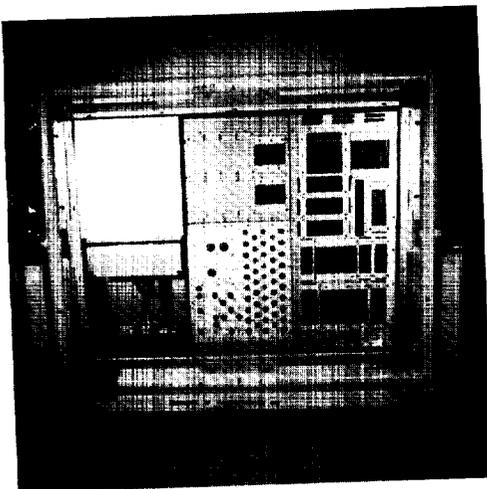
Figure 194
Photo No.: KSC-390C-1913.09
Dup. Neg. No.: L91-2536
LISAR No.: EL-1994-00281
Photo Credit: KSC
Photo Date: 3/13/90
Location: KSC SAEF II
Subject: Postflight Survey of Tray B9

Figure 194 (Postflight). The right and left flanges and each end of the top flange of the tray have abrasions from prelaunch testing. Most test specimens are intact except in the upper left center one-third where many thin films are damaged or missing. Mounting hardware is discolored. The EECC located in the left section of the experiment tray has a dark brown discoloration on the mounting structure in the bottom of the tray.

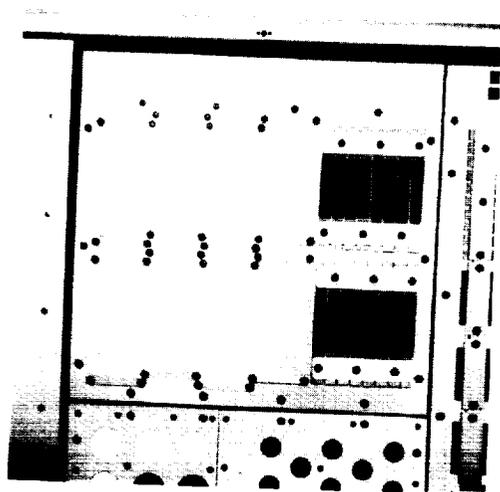
Figure 195
Photo No. KSC-390C-1913.11
Dup. Neg. No.: L91-2538
LISAR No.: EL-1994-00419
Photo Credit: KSC
Photo Date: 3/13/90
Location: KSC SAEF II
Subject: Postflight Detail of Upper Center of
Tray B9

Figure 195 (Postflight). This photograph of the upper center one-sixth of the tray shows that thin-film test specimens are missing. There is a brown discoloration at the upper left corner of the baseplate.

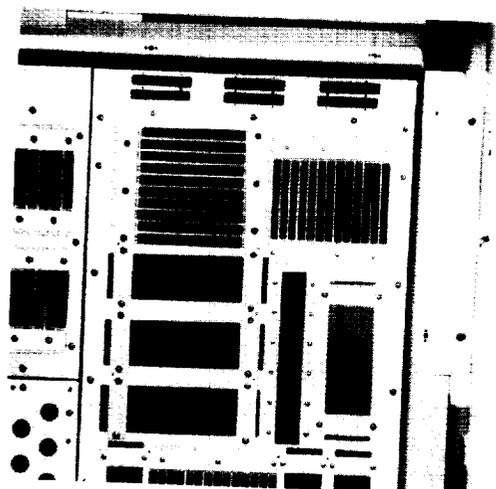
Figure 196
Photo No.: KSC-390C-1913.12
Dup. Neg. No.: L91-2539
LISAR No.: EL-1994-00420
Photo Credit: KSC
Photo Date: 3/13/90
Location: KSC SAEF II
Subject: Postflight Detail of Upper Right of Tray B9

Figure 196 (Postflight). This photograph of the upper right one-sixth of the tray shows that the test specimens are intact. However, some specimens are somewhat discolored and some have diagonal markings and patterns.

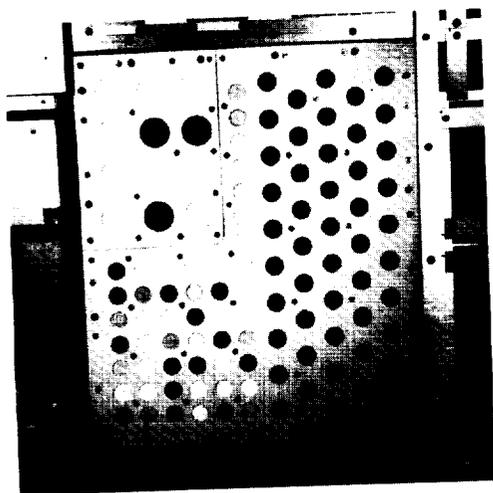
Figure 197
Photo No.: KSC-390C-1914.03
Dup. Neg. No.: L91-8108
LISAR No.: EL-1994-00421
Photo Credit: KSC
Photo Date: 3/13/90
Location: KSC SAEF II
Subject: Postflight Detail of Lower Center of
Tray B9

Figure 197 (Postflight). This photograph of the lower center one-sixth of the tray shows that some test specimens have changed color and some appear damaged.

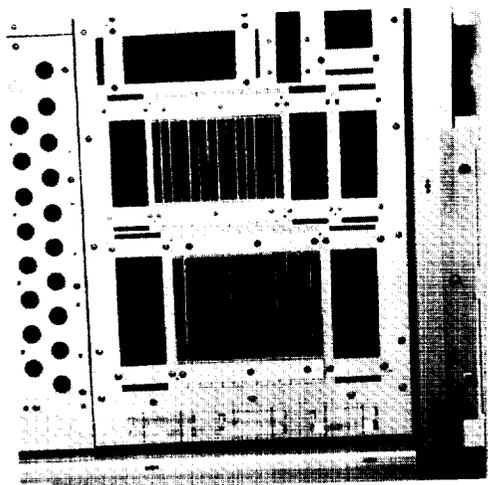
Figure 198
Photo No.: KSC-390C-1914.04
Dup. Neg. No.: L91-8109
LISAR No.: EL-1994-00422
Photo Credit: KSC
Photo Date: 3/13/90
Location: KSC SAEF II
Subject: Postflight Detail of Lower Right of Tray B9

Figure 198 (Postflight). This photograph of the lower right one-sixth of the tray shows that the test specimens are intact, but some are discolored and some have diagonal markings and patterns.

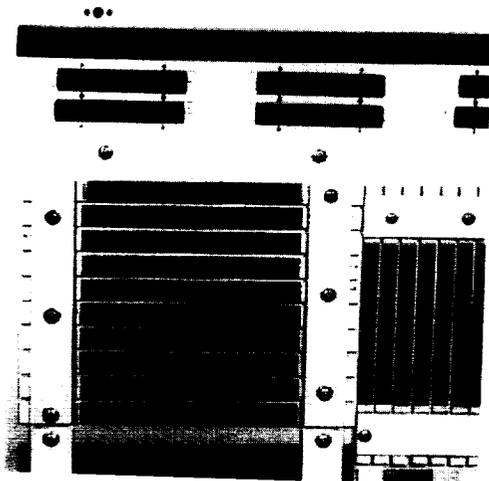
Figure 199
Photo No.: KSC-390C-1914.11
Dup. Neg. No.: L91-8116
LISAR No.: EL-1994-00423
Photo Credit: KSC
Photo Date: 3/13/90
Location: KSC SAEF II
Subject: Postflight Detail of Upper Right of Tray B9

Figure 199 (Postflight). This close-up photograph shows the general discoloration of a group of test specimens in the upper right of the tray.

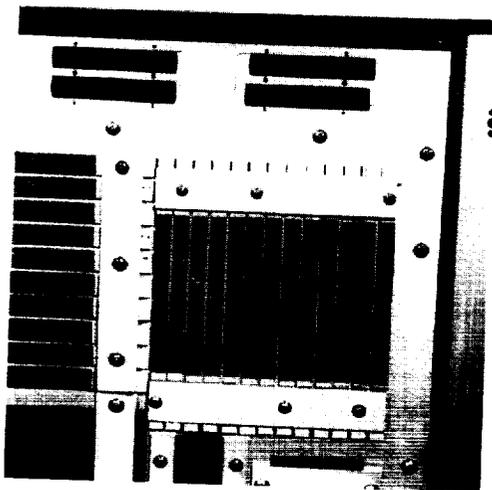
Figure 200
Photo No.: KSC-390C-1914.12
Dup. Neg. No.: L91-8117
LISAR No.: EL-1994-00424
Photo Credit: KSC
Photo Date: 3/13/90
Location: KSC SAEF II
Subject: Postflight Detail of Upper Right of Tray B9

Figure 200 (Postflight). This close-up photograph shows the general discoloration of a group of test specimens in the upper right of the tray.

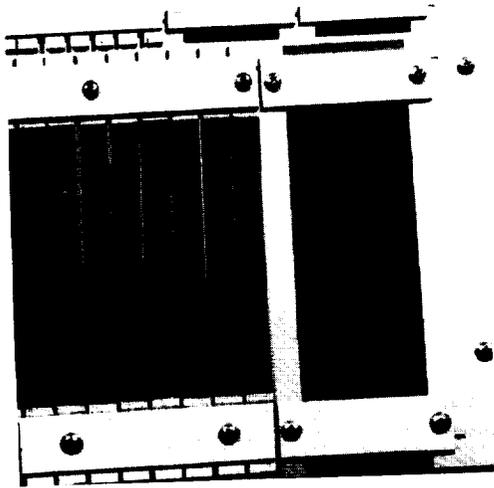
Figure 201
Photo No.: KSC-390C-1916.02
Dup. Neg. No.: L91-8083
LISAR No.: EL-1994-00425
Photo Credit: KSC
Photo Date: 3/13/90
Location: KSC SAEF II
Subject: Postflight Detail of Lower Right of B9

Figure 201 (Postflight). This close-up photograph shows the general discoloration of a group of test specimens in the lower right of the tray.

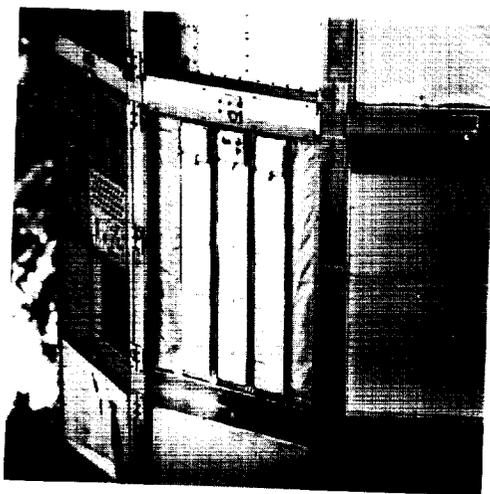
Figure 202
Photo No.: S32-78-076
Dup. Neg. No.: L90-10444
LISAR No.: EL-1994-00017
Photo Credit: JSC
Photo Date: 1/12/90
Location: In Flight
Subject: In-Flight Survey of Tray B10

Figure 202 (In Flight). The experiment consisted of three transverse flat-plate heat pipe modules, a power system for the heaters, a data acquisition and storage system, and an aluminum support structure. The surface of the experiment that was exposed to the space environment consisted of the exterior surfaces of the three heat pipe modules and silvered Teflon film. Thermal blankets covered the aluminum mounting hardware and openings between the hardware and the tray sidewalls. The raised surface at the end of each heat pipe module contained the fluid reservoir. The specular surface of the silvered Teflon film has become diffuse and appears white with numerous impact craters; black specks are visible on the white surfaces. Some areas of pronounced discoloration are visible.

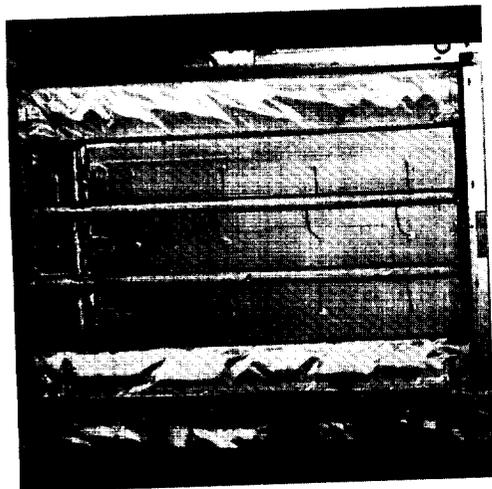
Figure 203
Photo No.: KSC-390C-612.02
Dup. Neg. No.: L92-17793
LISAR No.: EL-1994-00123
Photo Credit: KSC
Photo Date: 1/30/90
Location: KSC OPF
Subject: Postflight Survey of Tray B10

Figure 203 (Postflight). The thermal blanket with the patches across the lower edge of the photograph was part of the RMS thermal cover and was not associated with the experiment S1002. The specular surface of the silvered Teflon film has become diffuse and appears white. Numerous impact craters, black specks, and other discolorations are visible.

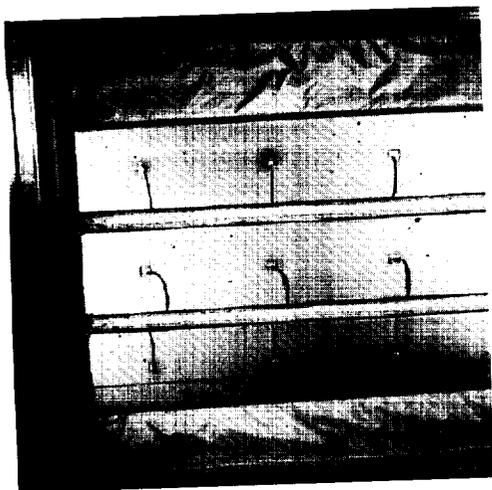
Figure 204
Photo No.: KSC-390C-1413.09
Dup. Neg. No.: L91-8987
LISAR No.: EL-1994-00363
Photo Credit: KSC
Photo Date: 3/1/90
Location: KSC SAEF II
Subject: Postflight Detail of the Left of Tray B10

Figure 204 (Postflight). This photograph of the left of the tray shows that the silvered Teflon film now appears diffuse. Space debris impacts appear as small black dots.

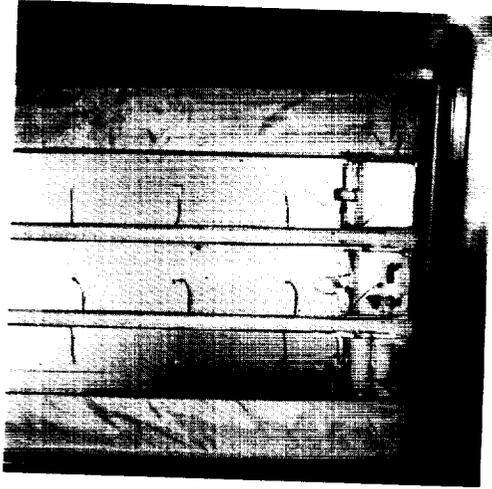
Figure 205
Photo No.: KSC-390C-1413.10
Dup. Neg. No.: L91-8988
LISAR No.: EL-1994-00347
Photo Credit: KSC
Photo Date: 3/1/90
Location: KSC SAEF II
Subject: Postflight Detail of Right Side of Tray B10

Figure 205 (Postflight). This photograph of the right of the tray shows that the silvered Teflon film now appears diffuse. Space debris impacts appear as small black dots. There is an area of brown discoloration on the right end of the center heat pipe module.

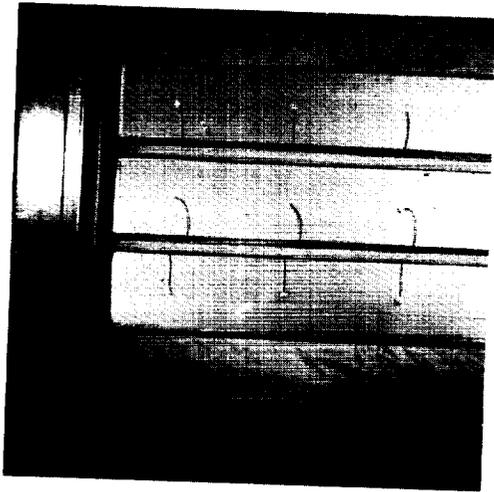
Figure 206
Photo No.: KSC-390C-1413.11
Dup. Neg. No.: L91-8989
LISAR No.: EL-1994-00348
Photo Credit: KSC
Photo Date: 3/1/90
Location: KSC SAEF II
Subject: Postflight Detail of Lower Left of Tray B10

Figure 206 (Postflight). This photograph of the lower left of the tray shows that the silvered Teflon film now appears diffuse. Space debris impacts appear as small black dots.

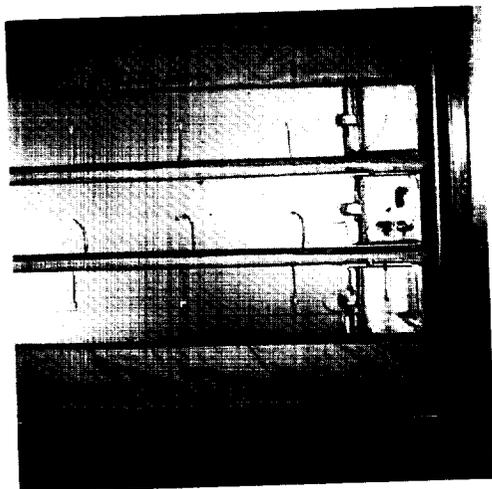
Figure 207
Photo No.: KSC-390C-1413.12
Dup. Neg. No.: L91-8990
LISAR No.: EL-1994-00349
Photo Credit: KSC
Photo Date: 3/1/90
Location: KSC SAEF II
Subject: Postflight Detail of Lower Right of
Tray B10

Figure 207 (Postflight). This photograph of the lower right of the tray shows that the silvered Teflon film now appears diffuse. Space debris impacts appear as small black dots. There is an area of brown discoloration on the right end of the center heat pipe module.

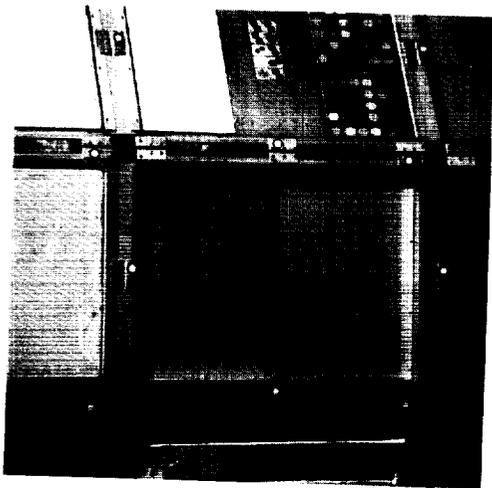
Figure 209
Photo No.: S32-78-038
Dup. Neg. No.: L90-10433
LISAR No.: EL-1994-00009
Photo Credit: JSC
Photo Date: 1/12/90
Location: In Flight
Subject: In-Flight Survey of Tray B11

Figure 209 (In Flight). The discolorations on the lower left sidewall of the experiment tray appear to be fingerprints from prelaunch handling. A portion of the pink and greenish-gray tint on the two debris panels are by-products of the chromic anodize coating process; however, part of the intensity can be attributed to reflections of the blue sky. The vertical streaks on the right debris panel are by-products of chromic anodizing that have been enhanced by the blue reflection. A light irregular discoloration is visible on the left debris panel; it starts near the center of the left edge and progresses down and to the right. The light band along the vertical edge of the left debris panel is a reflection from the tray sidewall.

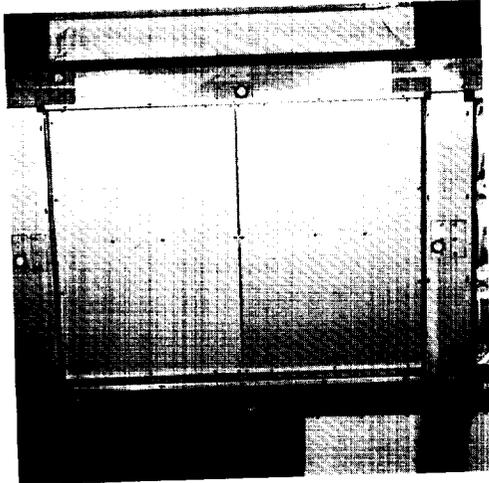
Figure 210
Photo No.: KSC-390C-1028.07
Dup. Neg. No.: L90-13381
LISAR No.: EL-1994-00141
Photo Credit: KSC
Photo Date: 2/9/90
Location: KSC SAEF II
Subject: Postflight Survey of Tray B11

Figure 210 (Postflight). The postflight photograph was taken in the SAEF II at KSC prior to the removal of the experiment from the LDEF. The pink and greenish-gray tints on the two debris panels are by-products of the chromic anodize coating process and are not attributed to contamination or exposure to the space environment. The dark streaks observed on the right debris panel in the in-flight photograph are no longer visible because the reflection of the sky is not present. However, the light irregular discoloration starting near the center of the left edge is clearly visible on the left debris panel. The light band along the sides and across the bottom of the panels is caused by light reflecting from the tray sidewall.

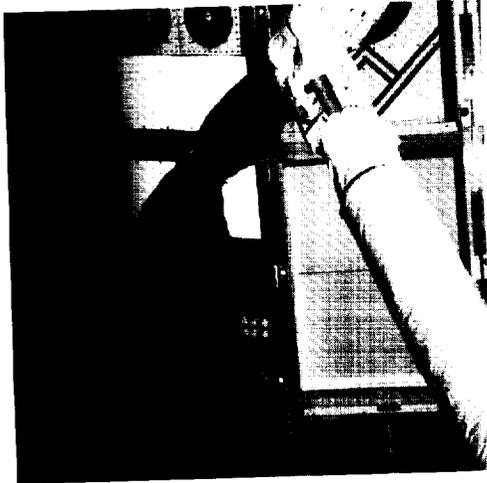
Figure 212
Photo No.: S32-78-026
Dup. Neg. No.: L90-10429
LISAR No.: EL-1994-00005
Photo Credit: JSC
Photo Date: 1/12/90
Location: In Flight
Subject: In-Flight Survey of Tray B12

Figure 212 (In Flight). The in-flight photograph is covered by the shadow from the orbiter RMS arm and cannot be readily compared with the preflight photograph. The surface area that can be observed does not seem to be significantly degraded.

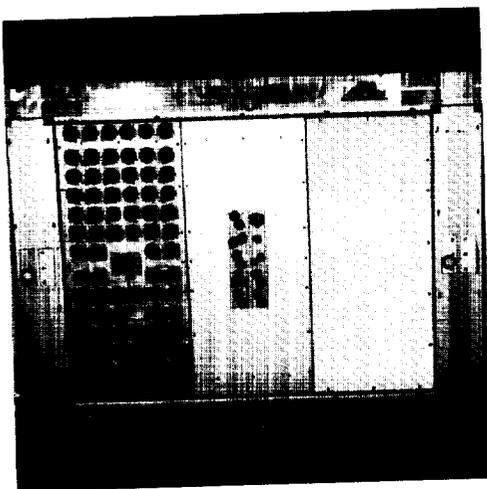
Figure 213
Photo No.: KSC-390C-1069.12
Dup. Neg. No.: L90-13492
LISAR No.: EL-1994-00204
Photo Credit: KSC
Photo Date: 2/8/90
Location: KSC SAEF II
Subject: Postflight Survey of Tray B12

Figure 213 (Postflight). The postflight photograph shows little change to the exposed surfaces when compared with the preflight photograph. Although not noticeable in the photograph, a light coating of contamination was visible on all experiment surfaces in this location. The difference in the colors of the IDE detectors that are located on the left mounting plate is a result of the reflected surroundings and is not related to space exposure. The EPDS thermal cover on the right side of the tray shows a light coating of brown contamination on the Chemglaze II A-276 white paint. Markings along the top of the photograph are due to film processing.

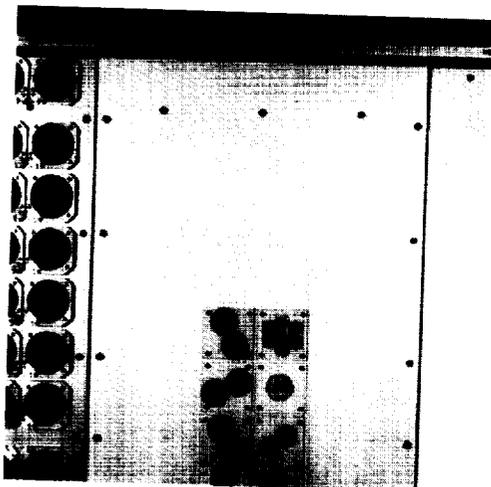
Figure 215
Photo No.: KSC-390C-1737.11
Dup. Neg. No.: L91-8190
LISAR No.: EL-1994-00235
Photo Credit: KSC
Photo Date: 3/8/90
Location: KSC SAEF II
Subject: Postflight Detail of Upper Center of
Tray B12

Figure 215 (Postflight). This photograph is of the upper center one-sixth of the tray. The center section cover plate shows little change except that a light coat of brown contamination can be observed on all surfaces. The color of the bonding material, which was used to secure several thin sapphire specimens to individual mounting plates at the bottom of the photograph, has changed from pink to gold. For one specimen, the bonding material is more gray than gold in color. This color difference has been attributed to the specimen being considerably thicker.

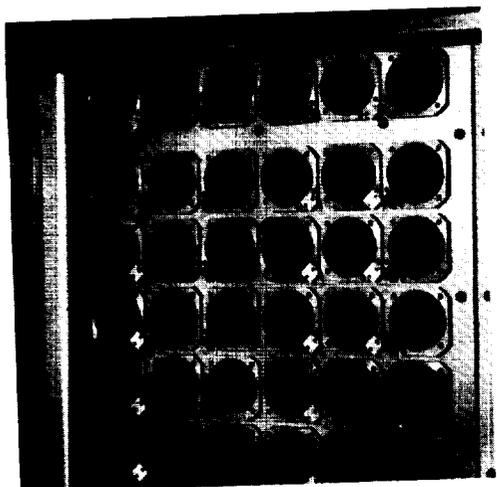
Figure 216
Photo No.: KSC-390C-1739.06
Dup. Neg. No.: L91-8197
LISAR No.: EL-1994-00236
Photo Credit: KSC
Photo Date: 3/8/90
Location: KSC SAEF II
Subject: Close-up of Upper Left of Tray B12

Figure 216 (Postflight). This close-up photograph is of the upper left one-sixth of the tray. The different colors of the impact detectors are caused by reflections of the surroundings. There are some space debris impact craters visible on some sensors. A large impact crater is visible on the sensor located second from the right in the bottom row. There also appear to be areas of discoloration or contamination around the edges of some sensors.

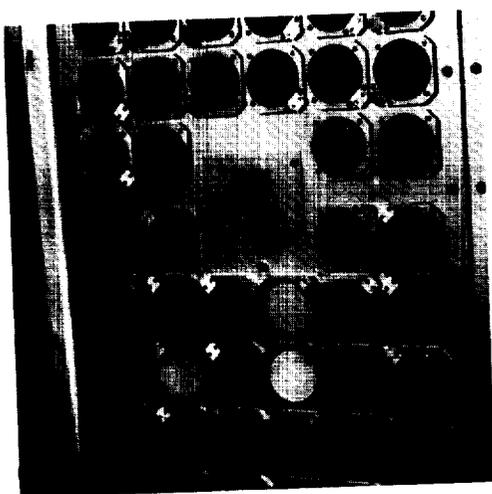
Figure 217
Photo No.: KSC-390C-1739.07
Dup. Neg. No.: L91-8198
LISAR No.: EL-1994-00237
Photo Credit: KSC
Photo Date: 3/8/90
Location: KSC SAEF II
Subject: Postflight Detail of Center Left of Tray B12

Figure 217 (Postflight). This photograph is of the center left one-third of the tray. Space debris impact craters are visible on some of the sensors. The different colors of the impact detectors are caused by reflections of the surroundings. Some reflections of room surroundings are visible in sensors in the left row. There also are areas of discoloration or contamination on or around the edges of some sensors. The solar sensor located near the bottom of the photograph has changed little. The color of the solar array baseplate shows indications of contamination and is a little darker than the detector mounting plate.

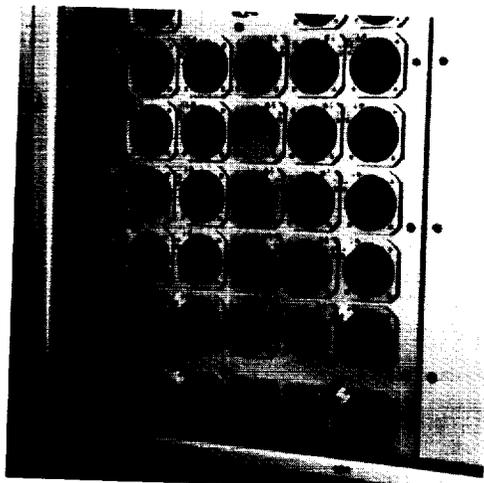
Figure 218
Photo No.: KSC-390C-1739.08
Dup. Neg. No.: L91-8199
LISAR No.: EL-1994-00238
Photo Credit: KSC
Photo Date: 3/8/90
Location: KSC SAEF II
Subject: Postflight Detail of Lower Left of Tray B12

Figure 218 (Postflight). This photograph is of the lower left one-sixth of the tray. Space debris impact craters are visible on some of the sensors. There also appear to be areas of discoloration or contamination on or around the edges of some sensors. The different colors of the impact detectors are caused by reflections of the surroundings.

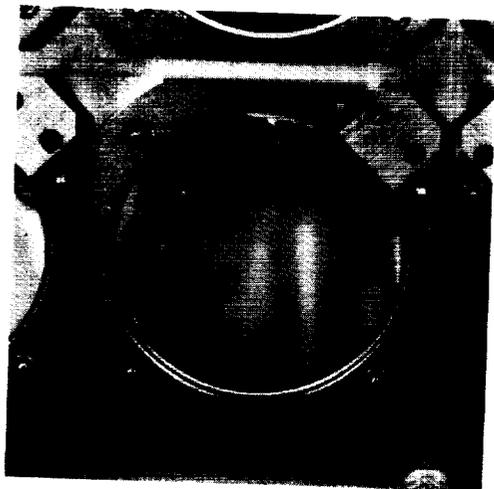
Figure 219
Photo No.: KSC-390C-1739.10
Dup. Neg. No.: L91-8201
LISAR No.: EL-1994-00239
Photo Credit: KSC
Photo Date: 3/8/90
Location: KSC SAEF II
Subject: Postflight Detail of Sensor on Tray B12

Figure 219 (Postflight). This close-up photograph is of a sensor and shows a space debris impact crater. This sensor is the second from the right in the second row from the bottom in the photograph shown in figure 218. Other small impacts are also visible.

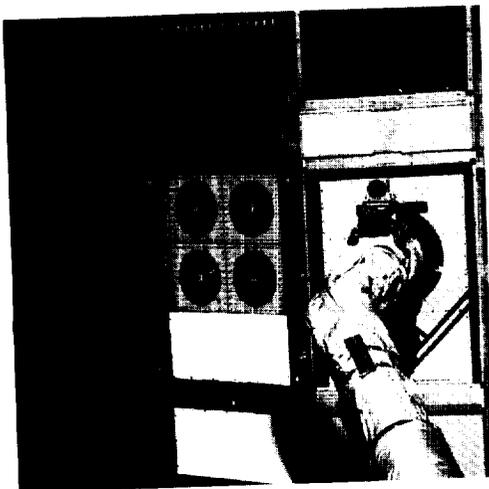
Figure 221
Photo No.: S32-89-048
Dup. Neg. No.: L90-10501
LISAR No.: EL-1994-00135
Photo Credit: JSC
Photo Date: 1/12/90
Location: In Flight
Subject: In-Flight Survey of Tray C1

Figure 221 (In Flight). The grapple tray assembly appears to be without physical damage. The camera on the RMS end effector blocks out over half the target attached to the top edge of the grapple fixture. The RMS wrist joint and shadow partially block a view of the black chevrons. The chromic-anodized aluminum mounting plate and the upper and lower flanges of the tray are discolored by a light tan stain.

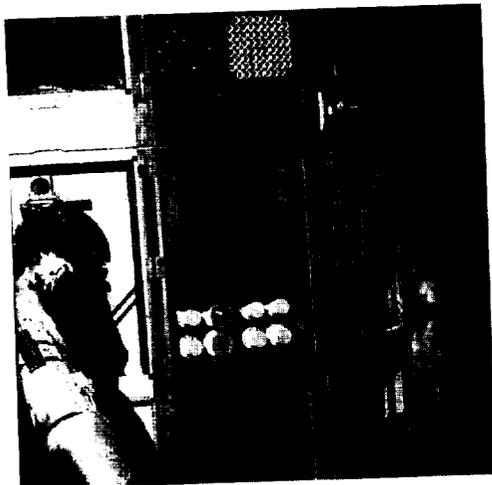
Figure 224
Photo No.: S32-89-029
Dup. Neg. No.: L90-10498
LISAR No.: EL-1994-00133
Photo Credit: JSC
Photo Date: 1/12/90
Location: In Flight
Subject: In-Flight Survey of Tray C2

Figure 224 (In Flight). A brown stain is on the experiment hardware within the tray. Experiment AO015 has survived the extended mission with no visible damage. The Kapton covers are intact and all hardware is securely in place. Experiment AO187-2 capture cells have been severely degraded. Few, if any, of the 40 capture cell metallized Mylar covers survived the total mission. For many cells, pieces of the failed capture cover have curled into tight conical needles and are attached to the edges of the aluminum mounting frame.

The EECC containing experiment M0006 appears to be in excellent shape.

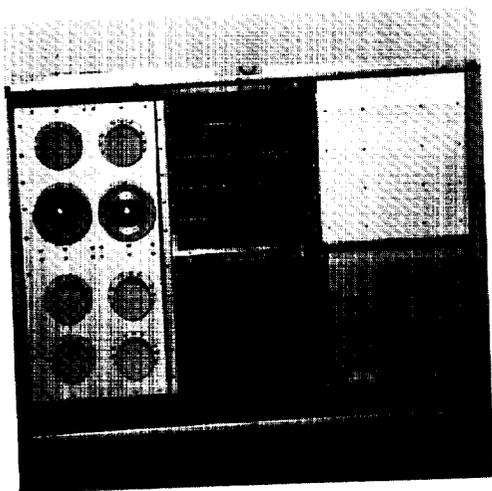
Figure 225
Photo No.: KSC-390C-609.09
Dup. Neg. No.: L92-17835
LISAR No.: EL-1994-00121
Photo Credit: KSC
Photo Date: 1/30/90
Location: KSC OPF
Subject: Postflight Survey of Tray C2

Figure 225 (Postflight). Most hardware is coated with a light brown or tan stain. Only one metallized Mylar cover for experiment AO187-2 survived the total mission. For other cells, pieces of the failed metallized Mylar cover curled into a tight conical shape and adhered to the edges of the aluminum mounting frame.

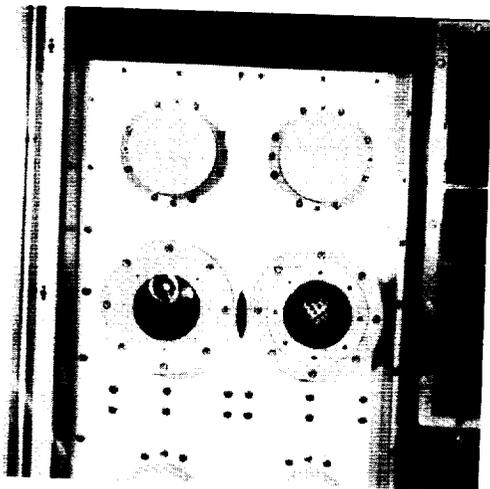
Figure 226
Photo No.: KSC-390C-1918.02
Dup. Neg. No.: L91-9048
LISAR No.: EL-1994-00427
Photo Credit: KSC
Photo Date: 3/13/90
Location: KSC SAEF II
Subject: Postflight Detail of Upper Left of Tray C2

Figure 226 (Postflight). This photograph is of the upper left one-sixth of the tray. The bio-stack canisters have no damage, but there is a dimple in one orange Kapton cover dome. The canisters were white prior to flight, but are now a light tan.

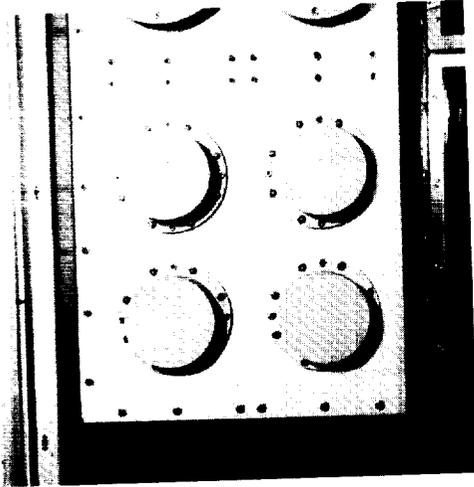
Figure 228
Photo No.: KSC-390C-1918.05
Dup. Neg. No.: L91-9051
LISAR No.: EL-1994-00429
Photo Credit: KSC
Photo Date: 3/13/90
Location: KSC SAEF II
Subject: Postflight Detail of Lower Left of Tray C2

Figure 228 (Postflight). This photograph is of the lower left one-sixth of the tray. The canisters appear undamaged. The biostack canisters that were white prior to flight now have a light tan discoloration.

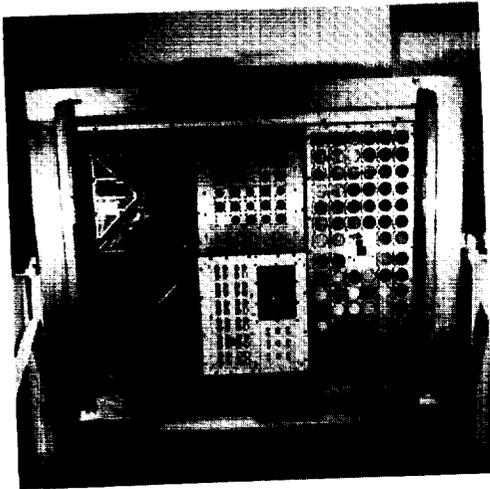
Figure 232
Photo No.: KSC-390C-1558.02
Dup. Neg. No.: L91-9090
LISAR No.: EL-1994-00213
Photo Credit: KSC
Photo Date: 3/5/90
Location: KSC SAEF II
Subject: Postflight Survey of Tray C3

Figure 232 (Postflight). Experiment surfaces have a brown stain that is consistent with other areas on the trailing side of the LDEF. Most noticeable is that the coverplate of experiment AO114, which was painted with white paint (S13G-LO), is now light tan.

Experiment AO023 has no visible damage. The die-cast frame, the mesh, the detector foils, and the bond joints are intact. Reflections from the photographic light sources are visible on the surfaces of specimens located in the cavities behind the cover plate.

The colors and designs on detectors of experiment AO201 are reflections of the surrounding area.
